## Electrical Signature Analysis Performed on Vertical Turbine Pump Motors in Municipal Application

Authored by William Kruger, Technical & Training Manager, ALL-TEST Pro, LLC, and Alex Panattoni, Control Systems Technician II, City of Henderson Department of Utility Services Electrical Section

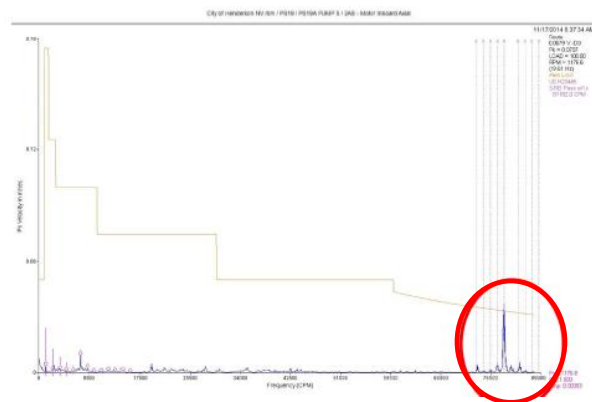
In November 2014, vibration analysis was performed as part of the plant's Predictive Maintenance Program. While those test results suggested the possibility of early bearing degradation in Motor 5, the rotor bar passing frequency was within range (**see Figure 1**). The vibration summary concluded that systems were operating within acceptable limits and that no maintenance actions needed to be taken at that time.

**Figure 1.** November 17, 2014 - 2AS - Motor Inboard Axial - Acceptable Vibration - Note: High Frequency Vibration ~81,102 cpm is Rotor Bar Passing Frequency. No Maintenance Action Recommended at this time. Continue to Monitor.

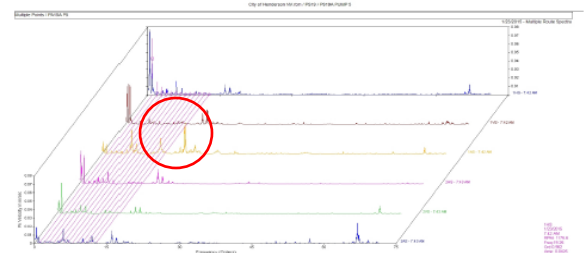
Spectral Waterfall – Data Points 1HS, 1VS, 1AS, 2HS, 2VS, 2AS – Standard Velocity

of a rotor problem, the results didn’t show the problem definitively. We knew the current was modulating and we put a time trace on it, but we needed to do more extensive testing,” explains Panattoni. At the maintenance team’s request, a third-party specialist went to the pump station to perform vibration analysis. When the vibration analysis did not indicate any electrical faults (pole pass frequency sidebanding) in the associated vibration FFT signatures (**see Figure 2**), the decision was made to bring in technical support from ALL-TEST Pro to perform additional testing.

**Figure 2.** January 23, 2015 - Vibration analysis for Motor 5 indicates the presence of low amplitude non-synchronous energy in the PeakVue timedomain data collected on the upper motor bearing. Only recommendations made were to monitor bearings for further degradation. Vibration analysis gave no indication of potential problems with the rotor.

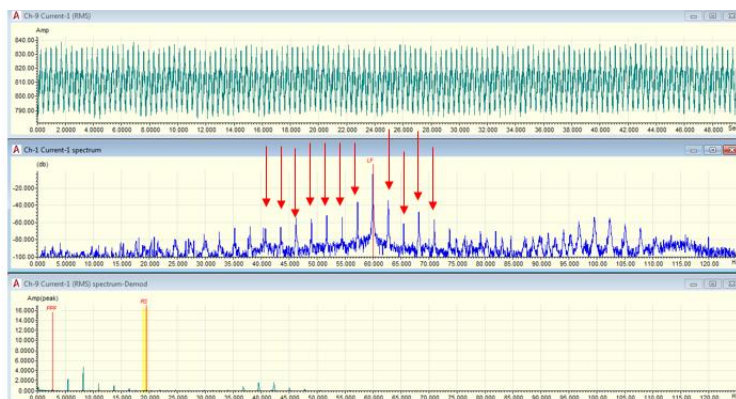
During the energized motor tests, data was taken at different times; first shortly after start-up, then again after the pump had been running. Of significance was the large change in rotor speed with a very small change in motor load. The rotor was running considerably below name plate; after running about thirty minutes, the rotor speed was 1171 RPM. This was also confirmed by an independent tach system provided by the third-party who performed the vibration analysis. While the results of the vibration analysis did not show any indications of rotor problems, the speed and the ESA data taken with the ATPOL II™ indicated that several rotor bars were broken (*see Figure 3*).

ESA Data from ATPOL II™		
	Pump 1	Pump 5
Pump Speed:	1183 RPM	1175 RPM
Demand Power:	738.98 HP	726.96 HP
Load:	100.7%	99.1%
Output Load:	507.95 KW	495 KW
Severity Rating:	6 out of 7	7 out of 7

The RPM values shown in the chart above are consistent with rotor bar anomalies. Motors 1 & 5 indicate an increased "slip frequency".

Figure 3. January 2015 – Electrical Signature Analysis using the ATPOL II™ - (Before repair) pole pass frequency side bands indicate very severe rotor bar damage; current draw was 820 amps and modulating around 16 amps.

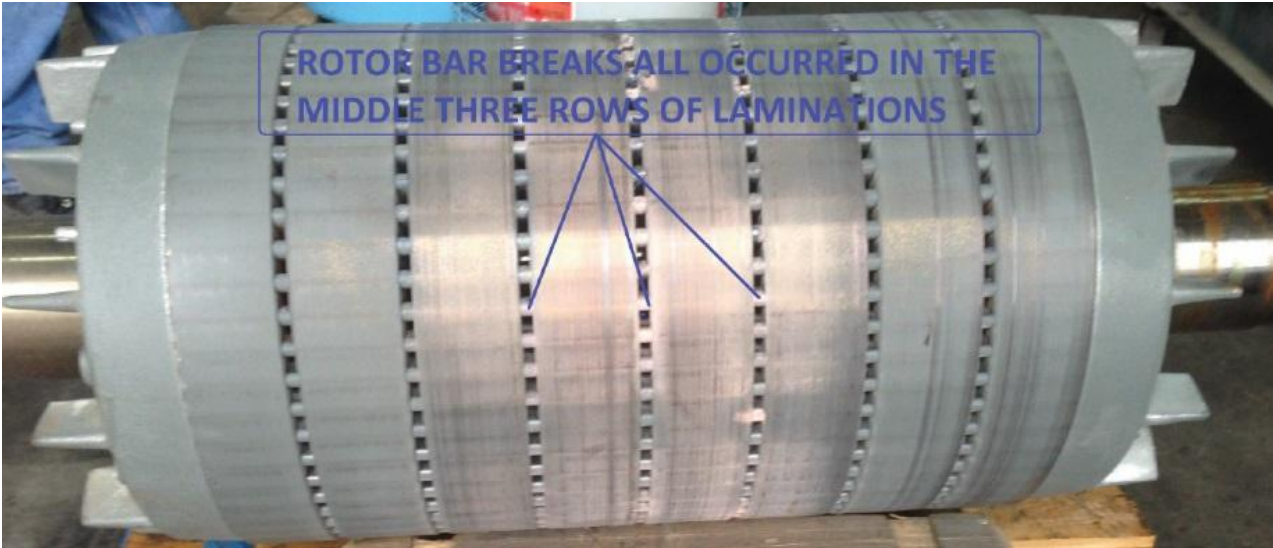
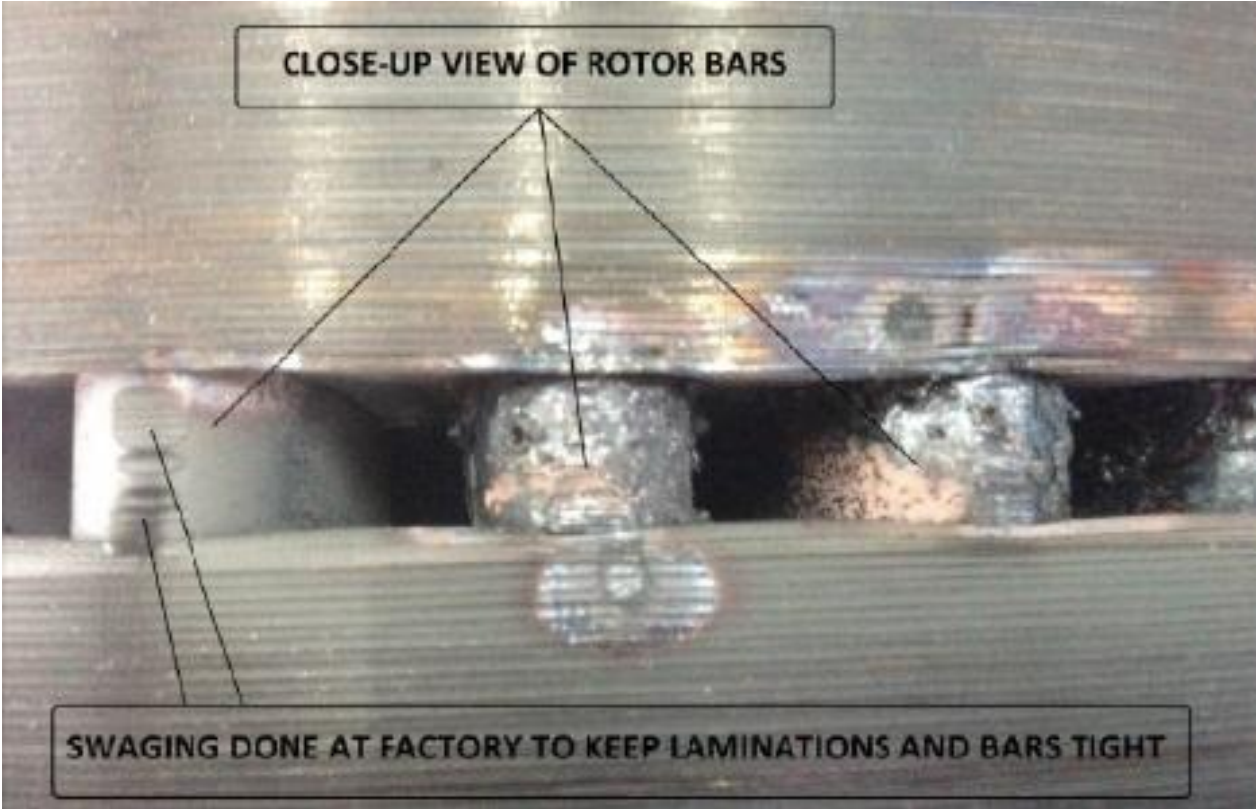
Rotor bars are solid continuous bars that run through the rotor's steel laminations, which are spaced to allow air flow to cool the rotor. Once the maintenance team received the report from the Electrical Signature Analysis, which showed severe indications of rotor bar issues (Pump 1 had a severity rating of 6 out of 7 and Pump 5 had a severity rating of 7 out of 7), they pulled Motor 5 and found that **30% of the rotor bars were in fact broken.**

*Rotor bar breaks all occurred in the middle three rows of laminations.*

After discussing the issues with the motor manufacturer and a third party motor repair company, the maintenance team chose to have both Motor 1 and Motor 5 rebuilt with copper rotor bars. Pumps 2, 3, and 4 had copper rotor bars and did not have the same issues as Pumps 1 and 5. The original rotor bars in Pump 1 and Pump 5 had been made of aluminum. This was believed to be the root cause of the problem. Because the motors at P-19A normally run 100% to 110% of load, there is a high current flowing through the rotor. This produces heat that causes expansion and contraction. Over a period of time, the aluminum rotor bar breaks under tension, then the arcing occurs at the spot of the break. The currents are then forced through the remaining bars, putting more loads on them and causing more broken bars, weakening the strength of the entire rotor. This issue would have eventually shorted out the stator winding by the increased operating temperature or arcing metal from the rotor, and would have caused the need for a rewind or possible scrapping of the entire motor, in addition to the repair or replacement of the rotor. Having the motors rebuilt with copper rotor bars enabled the maintenance team to avoid catastrophic failure of their vertical turbine pump motors.

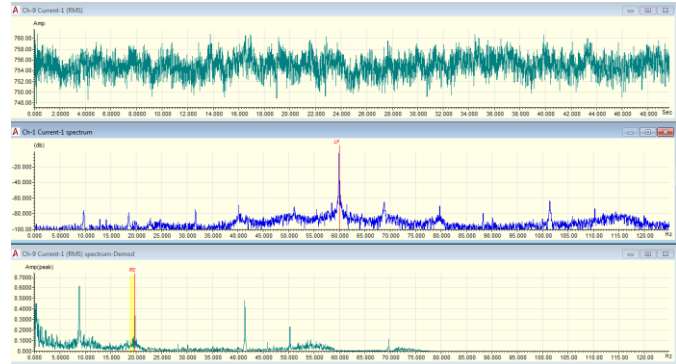
Motor 5 was rebuilt and installed in May of 2015. Another round of MVA and ESA testing was performed immediately after installation to ensure proper operation. The electrical signatures taken in May reported excellent rotor condition (see **Figure 4**). It also showed that rotor speed increased, while overall current dropped. The newly rebuilt Motor 1 was installed in September 2015 and a third round of testing was performed.

**Figure 4.** May 5, 2015 – Electrical Signature Analysis using the ATPOL II™ - (After repair) pole pass frequency side bands were gone and current draw was 754 amps with 2 amps modulation.

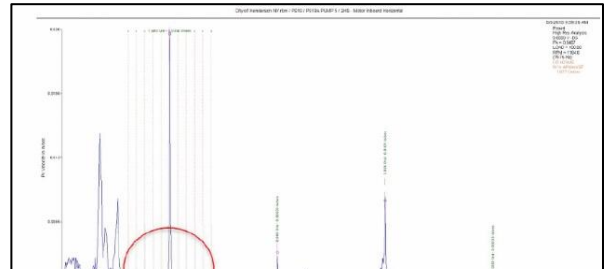
*Chart from third-party vibration analysis performed in May 2015: Rotor bar issues produce low-amplitude sideband sets spaced at "pole passing frequency". The red circle highlights the location of calculated pole pass frequency sidebands (vertical lines). The absence of these sidebands indicate motor rotor is in good health, as expected with a newly rebuilt rotor.*
