Electrical Signature Analysis for Power Plant Pump Performance Assessment

Performing the Electrical Signature Analysis

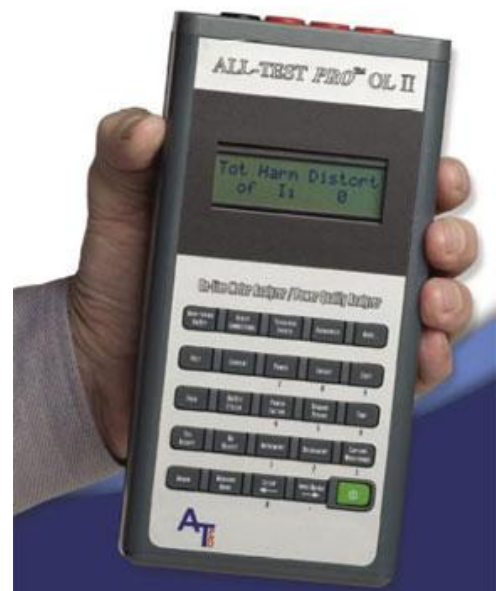
Dunn used the [ALL-TEST Pro Online II™](#) energized motor testing instrument to perform the electrical signature analysis. He connected the ATPOL II™ to the

system, which was set to a flow rate of 5600 GPM for the test. The motor terminal box was kept opened for the test, and the ATPOL II™ data collector was placed near the motor. The ATPOL II™ collected and transmitted the data via Bluetooth while Dunn and the maintenance team were positioned a safe distance away from the high voltage equipment.

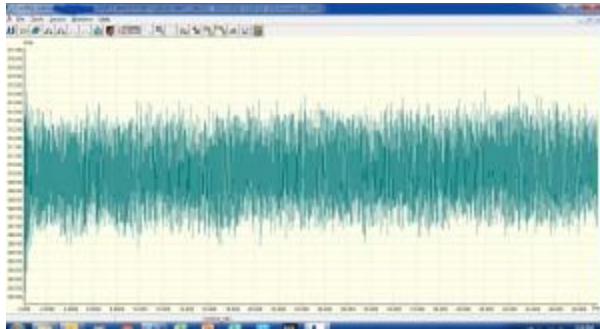
Above is a raw waveform of the current acquisition over 50 seconds. You can see the variation, in this case between about 306 and 313 amps.

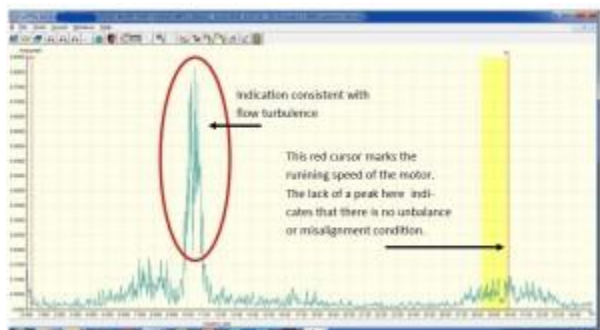
This is an FFT of the demodulated current spectrum where the pulsation is shown as a broad peak around 10 HZ. This is a typical indication of turbulent flow.

- The motor was electrically perfect with balanced current and voltage, and 90+ power factor.
- The motor and pump were mechanically excellent with no indications of misalignment or unbalance, bearing issues, rotor, or stator issues.
- Tests showed a significant fluctuation in the current draw, pulsing at about 10 Hz. Dunn and the team collectively determined that this was caused by non-laminar flow, or **turbulence in the system.**

The indication of turbulence on the two under-performing vertical service water pumps was a revelation; and what was more surprising to the maintenance team was that the turbulence had not been detected with any of the other tests. **It was only the Electrical Signature Analysis that had revealed the underlying cause of poor pump performance.**
